Re: Class 3 Groundwater Demonstration Report  
Copano Enterprises LLC, dba CE Ranch LLC, Copano Site (Beds 1-4)  
Aransas and San Patricio County, Texas  
9019 Settlement Agreement effective May 21, 2018  
TCEQ SWR No. 30097; EPA ID No. TXD008129983  
Customer No. CN605550557; Regulated Entity No. RN104914312

# Class 3 Groundwater Demonstration

*CE Ranch, LLC - Copano Property*

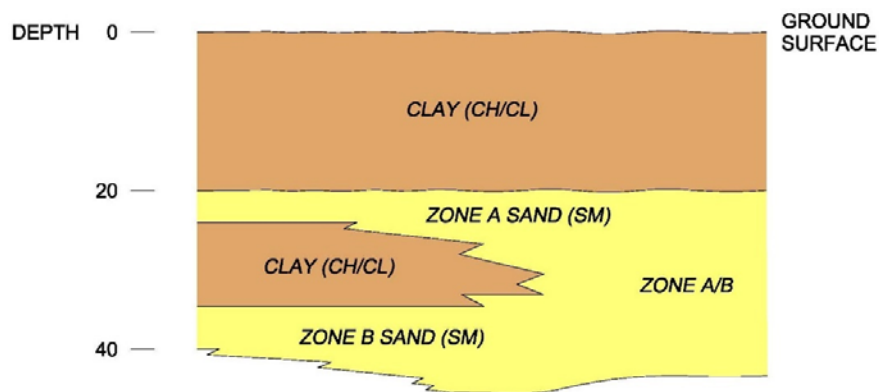
The surface soil observed at the Site is a medium to high plasticity clay that extends to a depth of approximately 20 feet below the ground surface (bgs). Beneath this surface clay is the uppermost GWBU (Zone A) that varies in composition from a silty to clayey sand, ranges in thickness from just a few feet to over 20 feet, and typically contains interbedded clay and silty clay. A deeper GWBU (Zone B) is present beneath Zone A and a clay confining unit (ranging from a few feet to over 10 feet thick). Zone B, typically represented by silty sand and less frequently as a clayey sand, also varies in thickness from a few feet to over 20 feet. Occasionally, the clay unit between Zones A and B is absent resulting in a thick sequence of sand with interbedded clay and silty clay and represented as Zone A/B. The subsurface stratigraphy is shown on the generalized section below.

Investigations at the facility have provided information about the Site subsurface geology and hydrogeology. In general, subsurface strata are part of the Quaternary (Pleistocene) Beaumont Formation, which consists of mostly clay, silt, sand and gravel deposited in stream channel, point bar, natural levee, and backswamp depositional environments. Subsurface complexity arises due to the interbedded nature of these deposits and reflects the various depositional environments of the Beaumont Formation. Multiple sand units are present in the subsurface that are typically separated by clays (i.e., confining units).

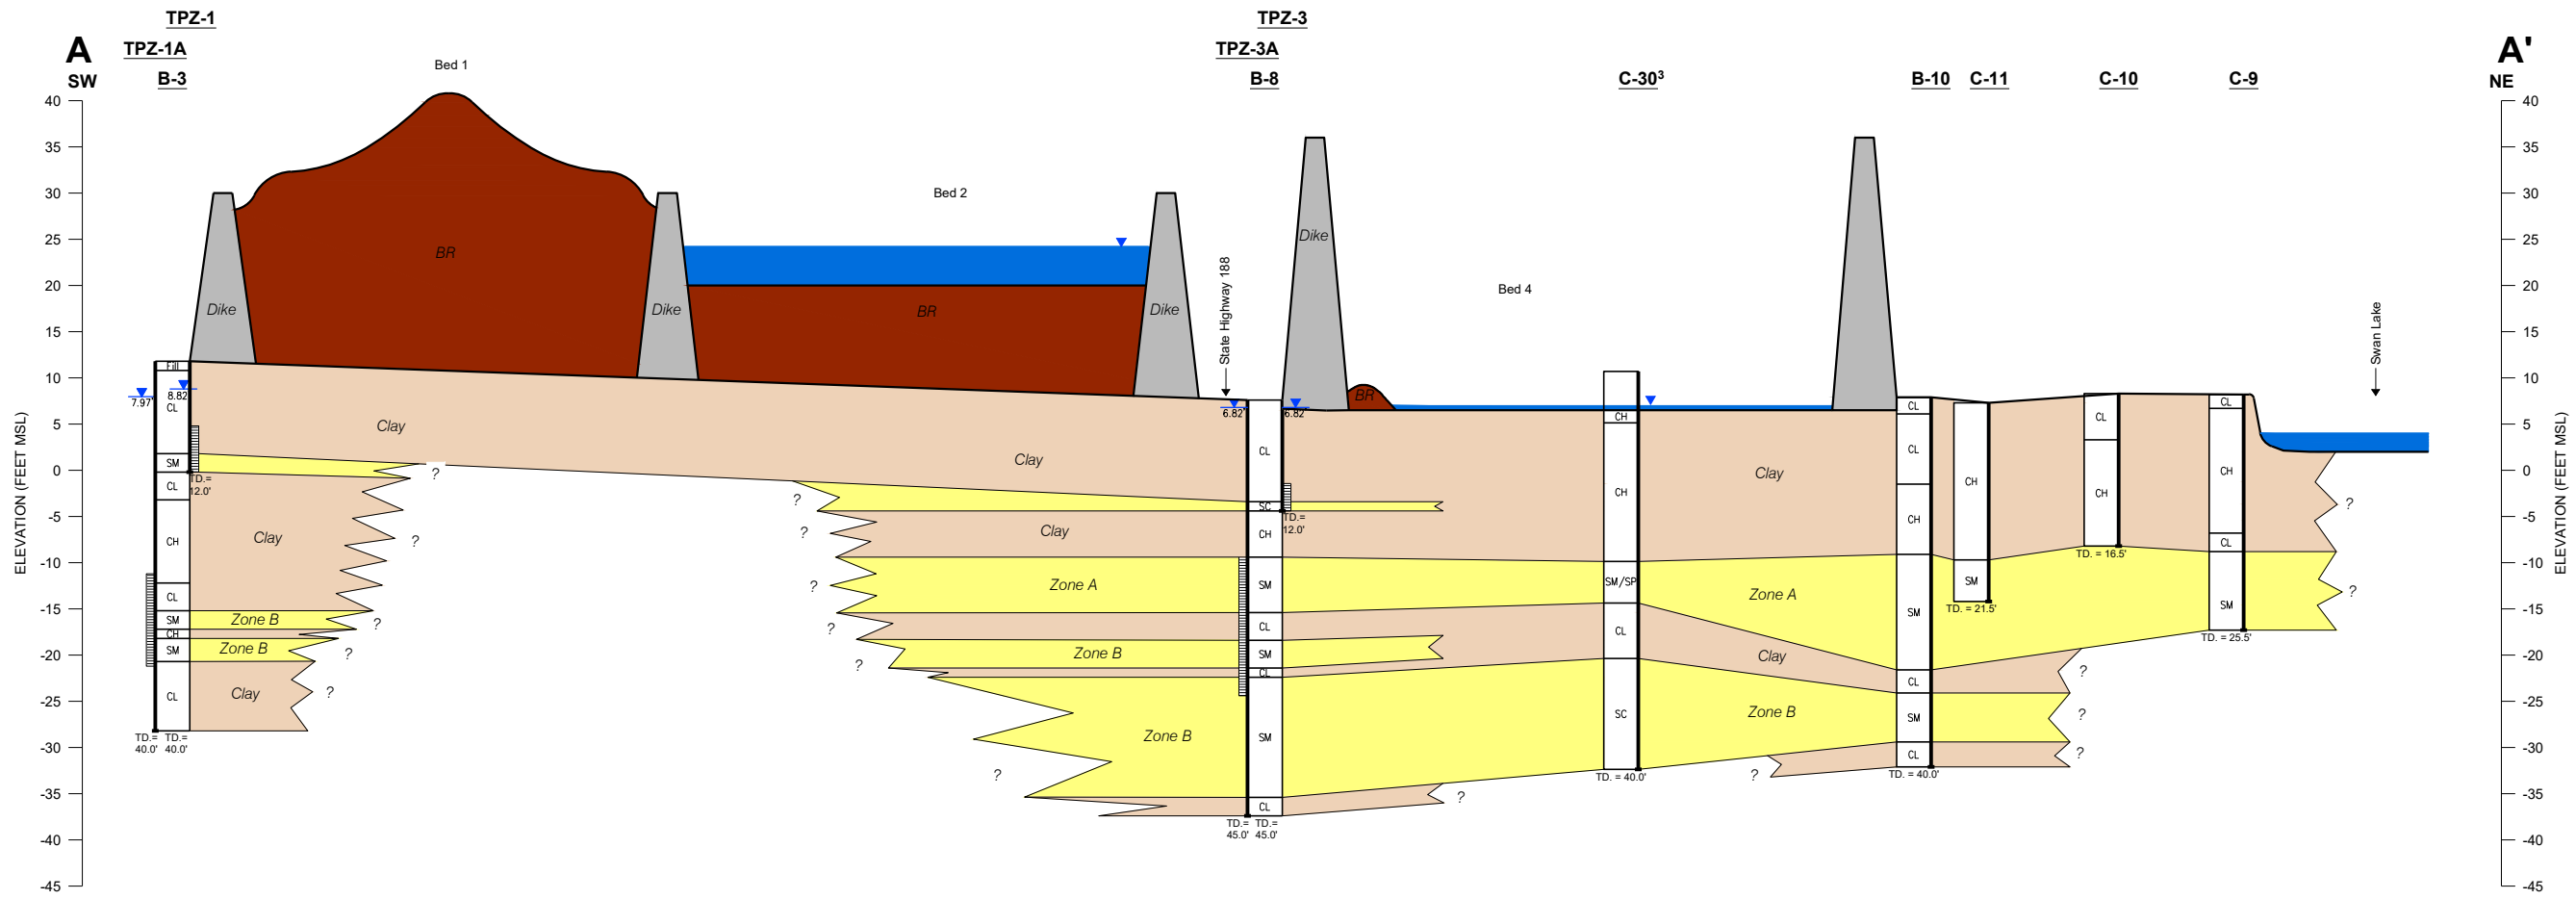
CLIENT	CE RANCH LLC	
PROJECT	COPANO PROPERTY	
TITLE	GEOLOGIC CROSS SECTION A-A'	
CONSULTANT	YYYY-MM-DD	2020-03-12
	DESIGNED	AJD
	PREPARED	AJD
	REVIEWED	MKW
	APPROVED	MKW
PROJECT NO.	REV.	FIGURE
19125525	0	2-1

Geologic cross-sections were prepared using available stratigraphic data (Figures 2-1, 2-2 and 2-3) and show the multiple interbedded sand and clay units described above.

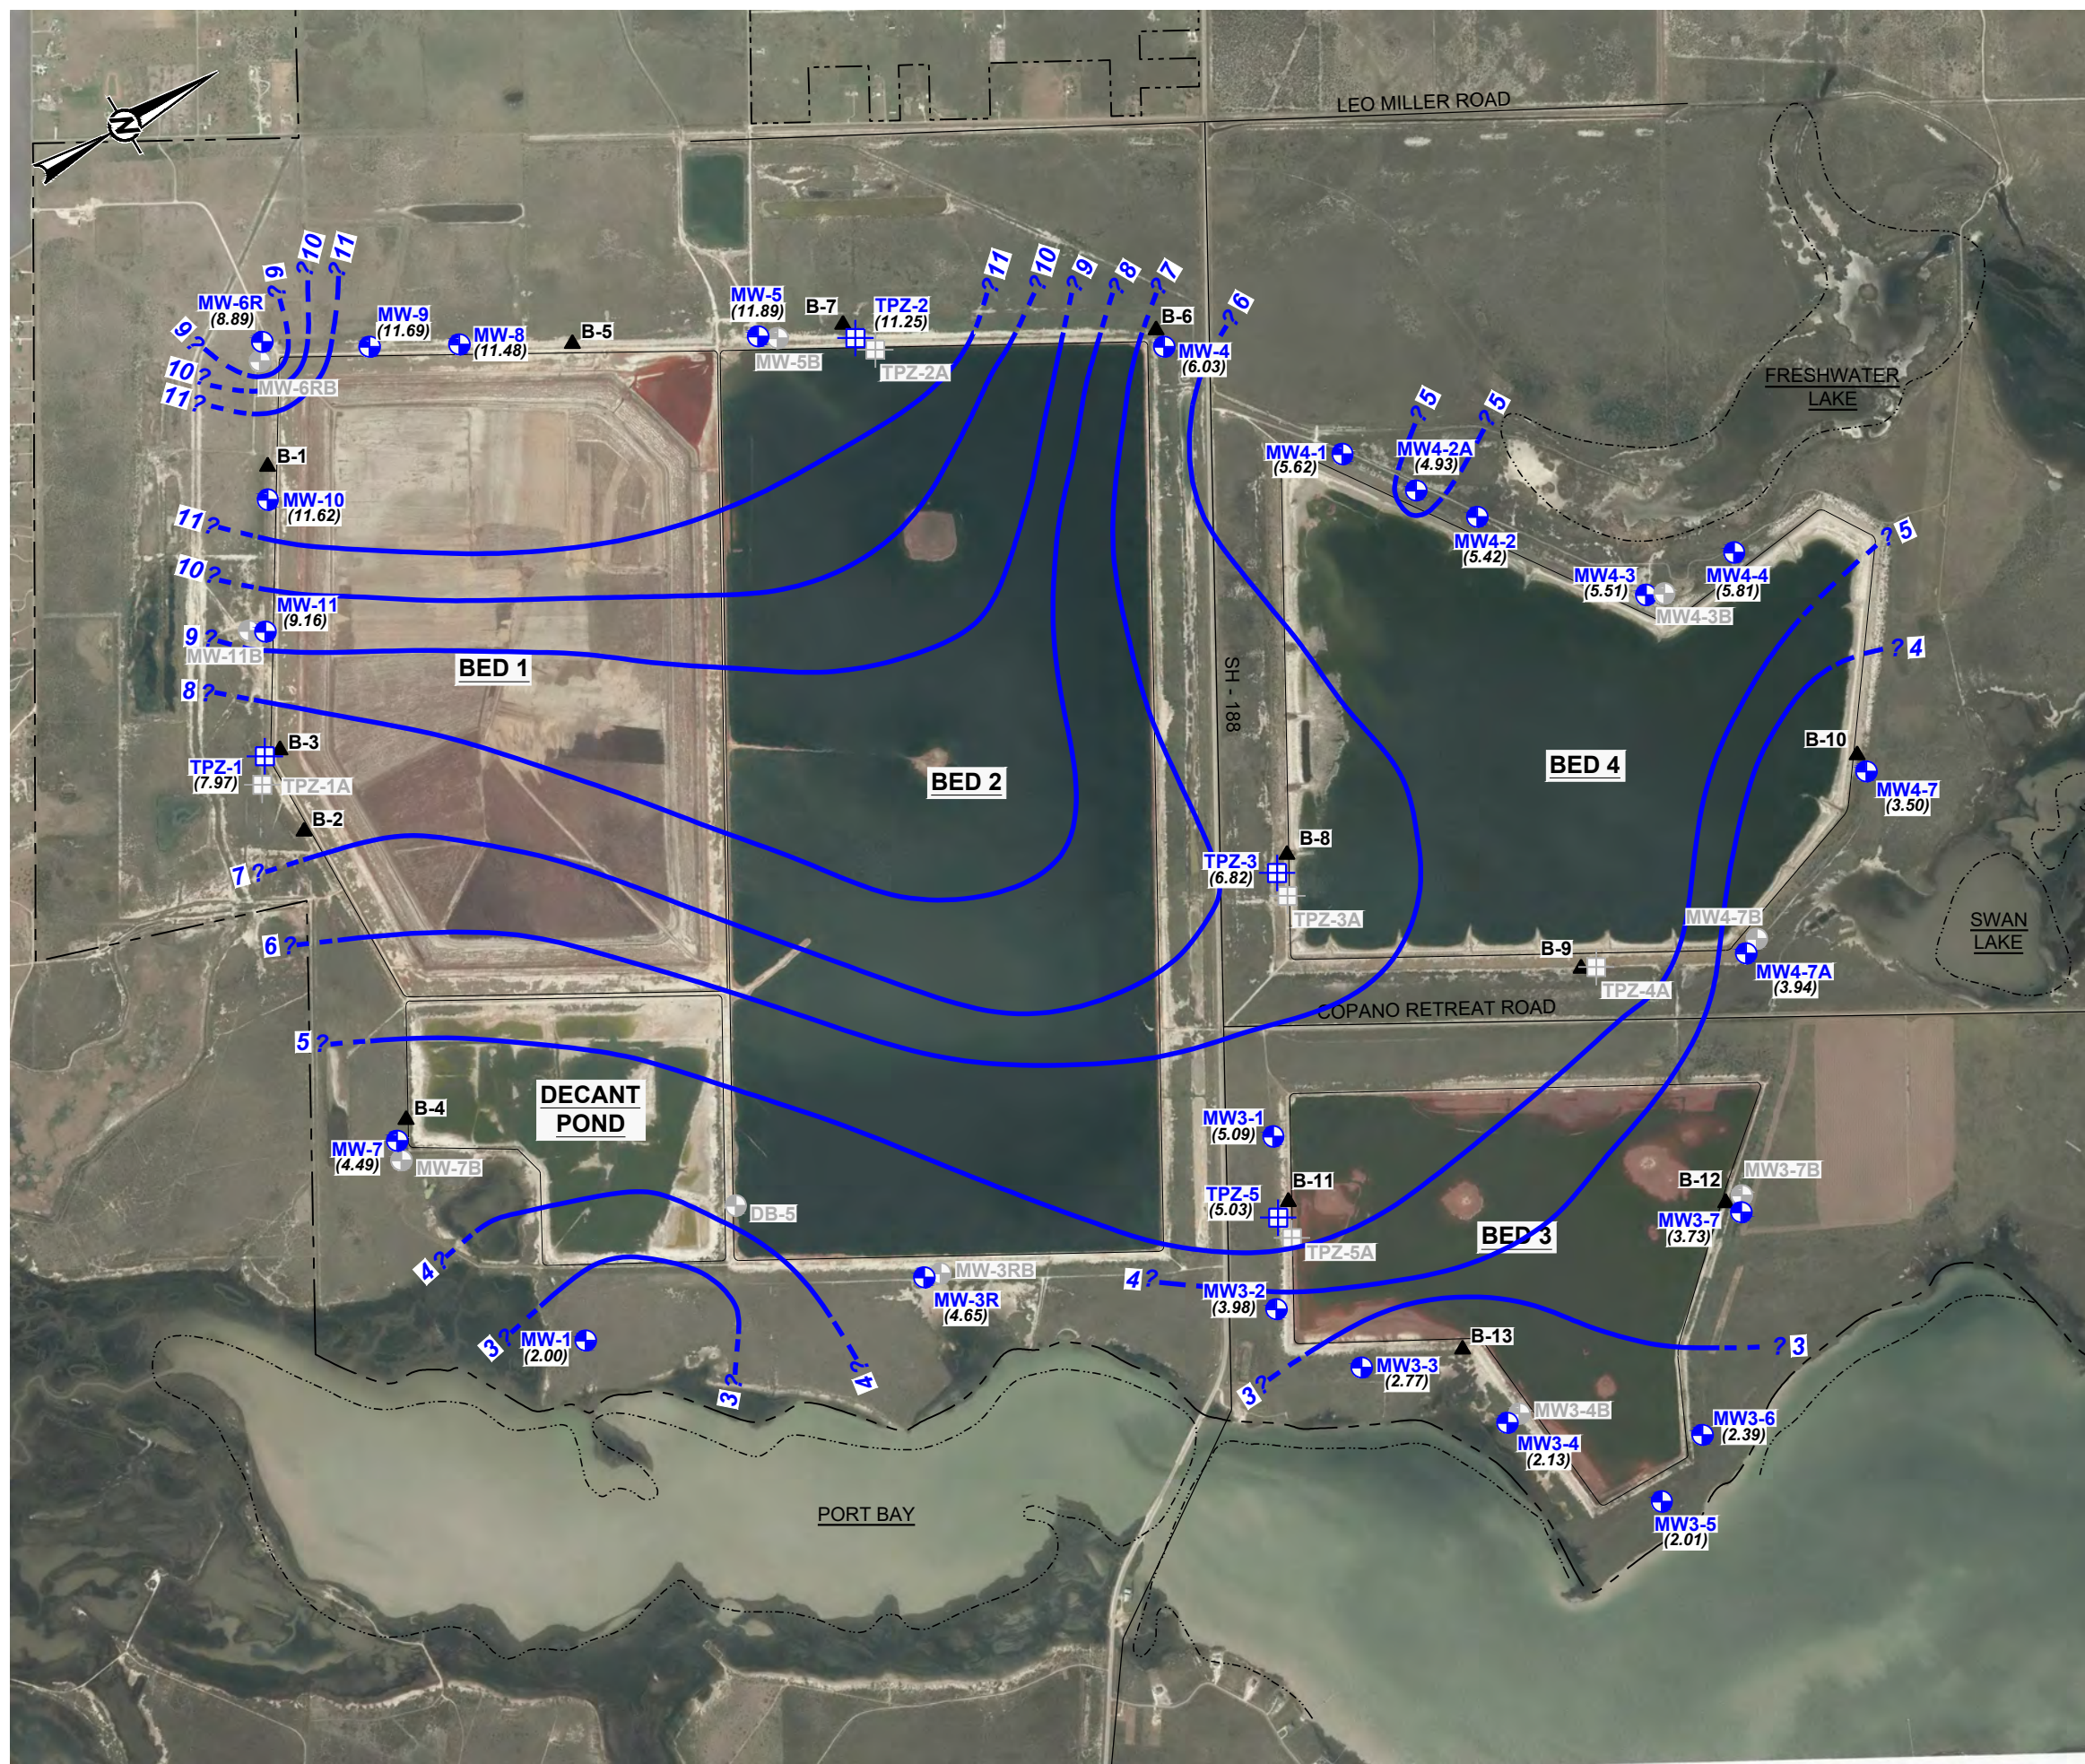
Figure 2-4: Potentiometric Surface Map (Zone A) – February 4, 2020

Groundwater in Zones A and B occur under confined conditions, i.e., the water level in a well is at a higher elevation than the top of the water bearing unit at that well location. Lateral groundwater flow in the upper water-bearing units ranges from toward the northeast to southeast towards Copano Bay and Port Bay. Potentiometric surface maps for Zones A and B prepared from water-level gauging data collected on February 4, 2020 are provided as Figures 2-4 and 2-5, respectively.

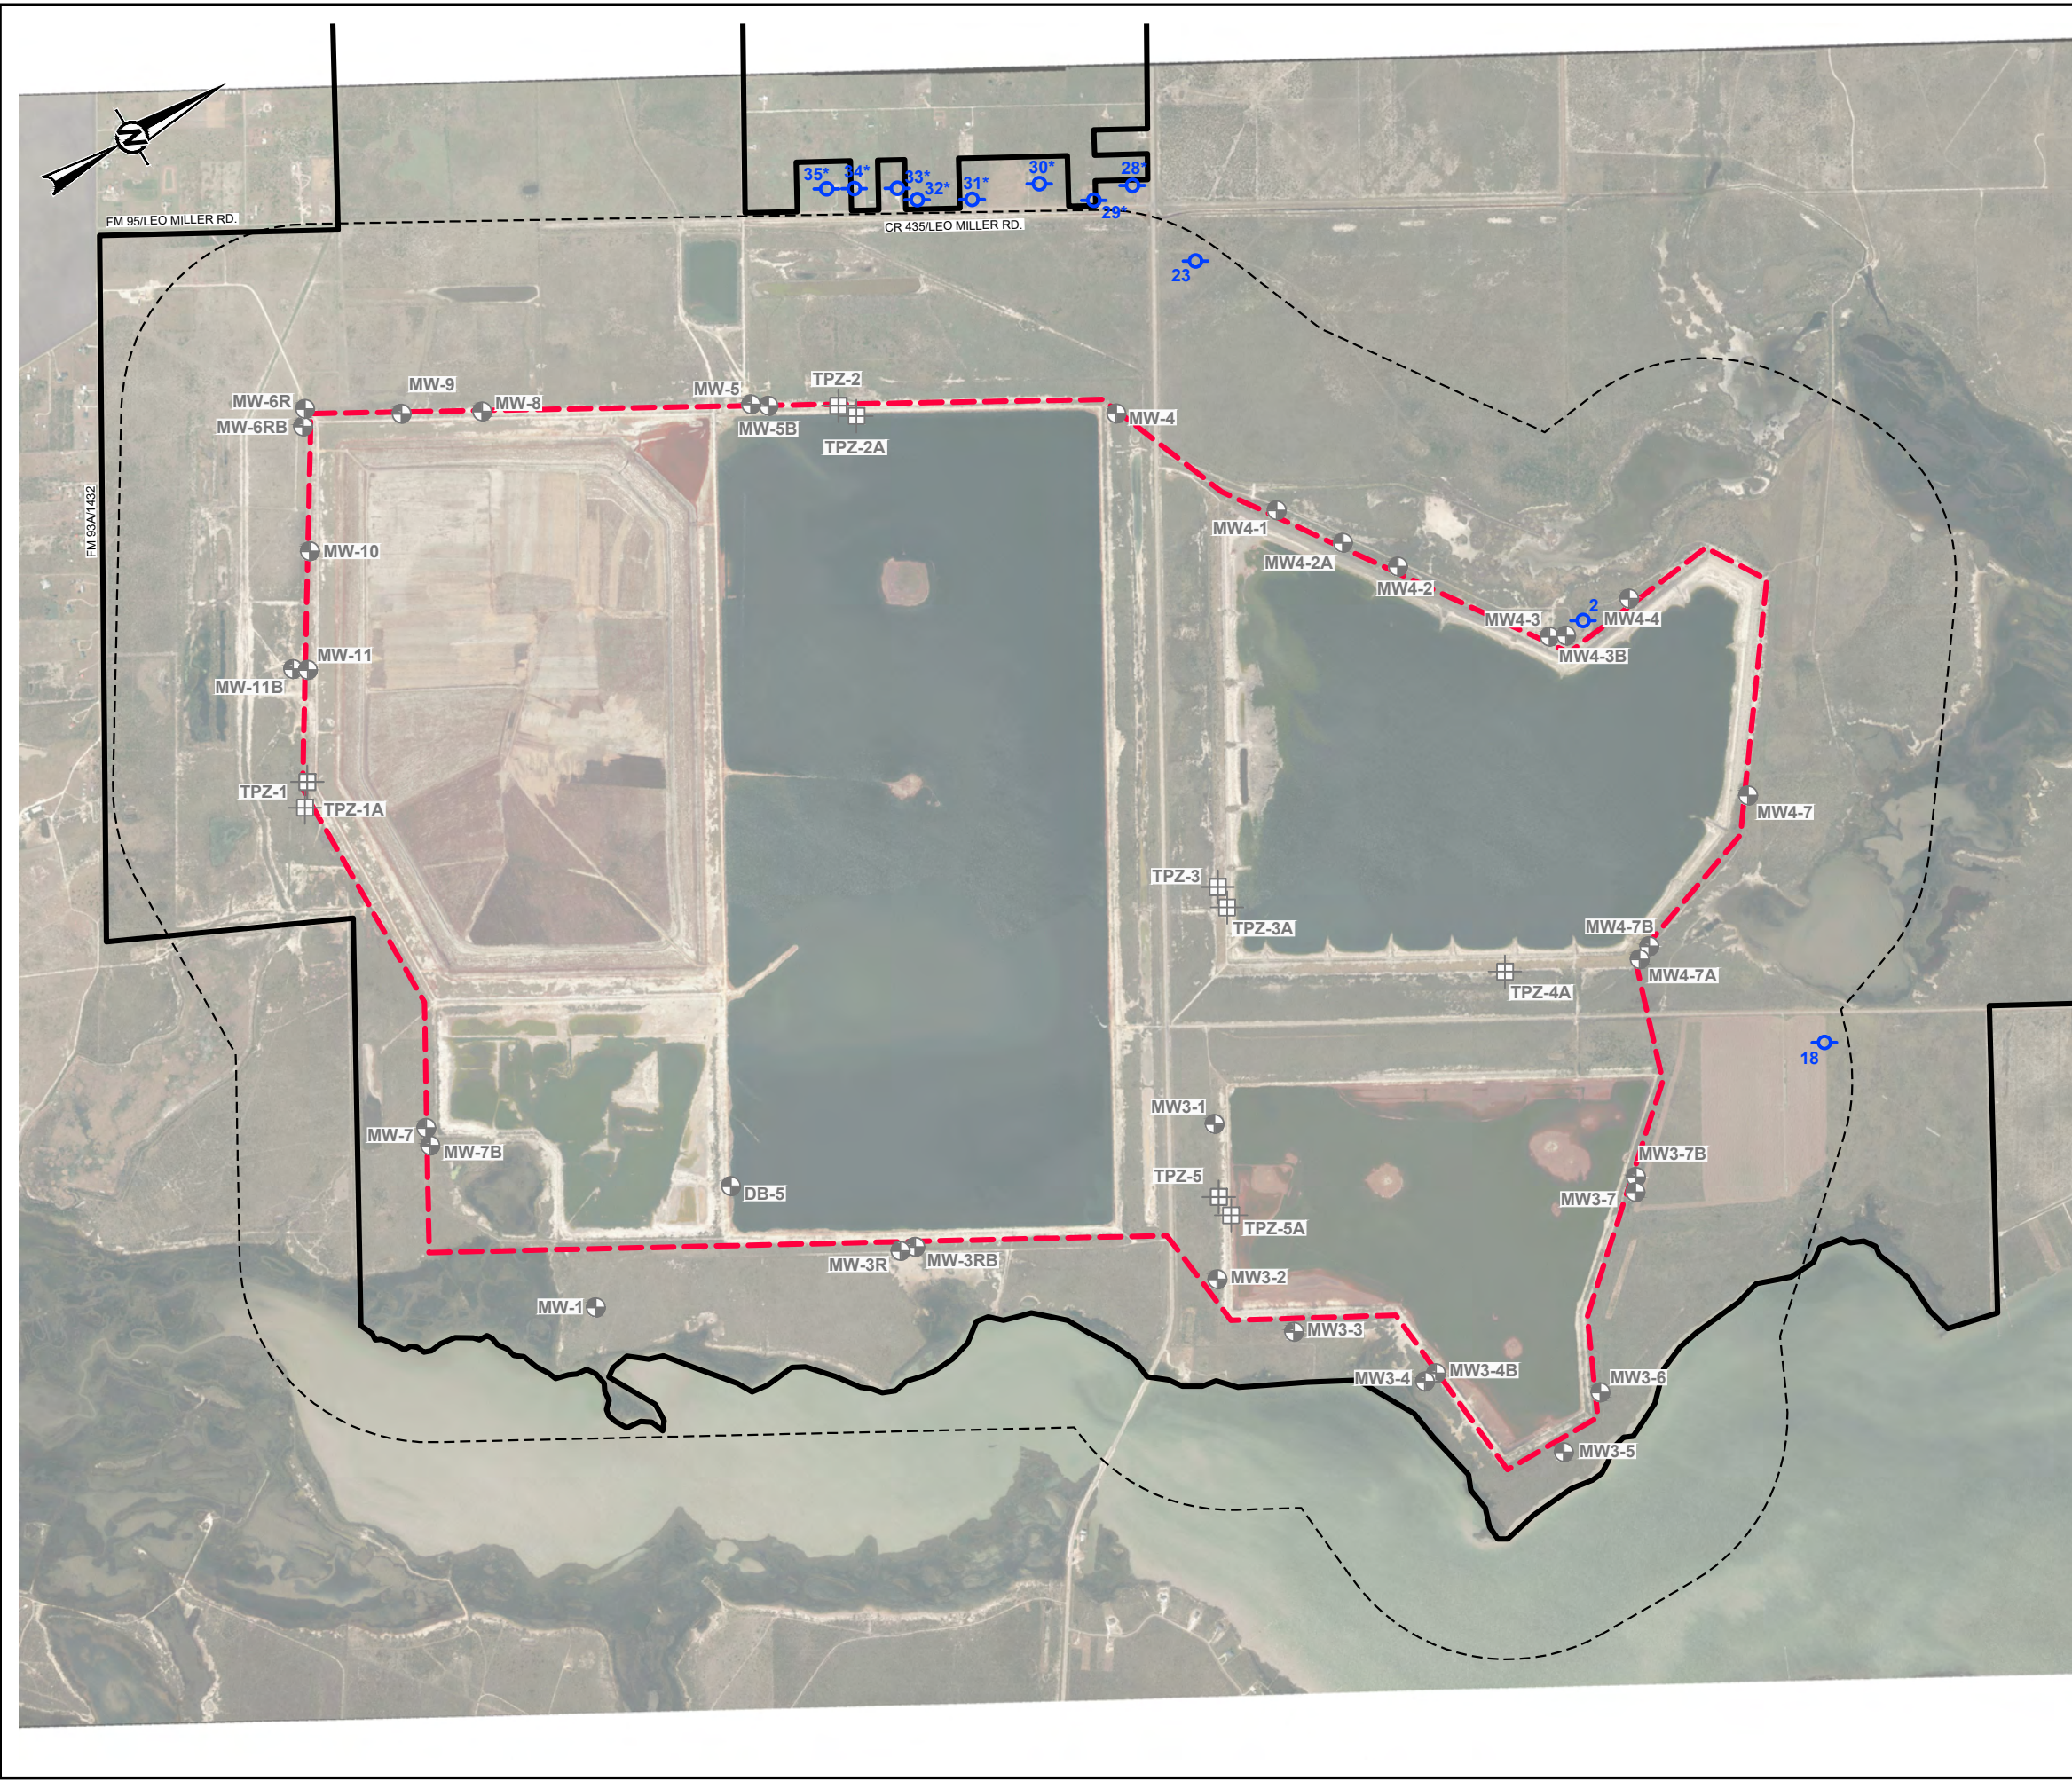
Figure 3-1: Water Well Location Map

Water well records obtained through the Texas Water Development Board (TWDB) and Banks Environmental Data, Inc. (Banks) were reviewed to identify the potential location of water wells within a 0.5-mile radius of the perimeter of Beds 1-4 and the Decant Pond. Well location and designated use information obtained from the TWDB and Banks was reviewed and verified by Golder personnel in the field to the extent possible. Many of the wells identified in the Banks report (Attachment 1) are either incorrectly mapped in the database with actual locations greater than 0.5 miles from the affected property or were not observed on the ground at the reported location (presumably abandoned, destroyed, plugged, etc.). A summary of Golder's review of the Banks records and other information is provided in Table 3-1. A map of water well locations is provided as Figure 3-1.

1. THE EXTENT OF AFFECTED GROUNDWATER HAS BEEN DELINEATED TO RESIDENTIAL HEALTH BASED VALUES FOR INGESTION.
2. ALL WATER WELLS PLOTTED WERE FOUND THROUGH BANKS DATABASE RESULTS EXCEPT WATER WELLS DENOTED WITH AN \*.

Three water wells were identified within a 0.5-mile radius of the affected property. These wells (State ID 79-63-802, 79-63-801 and 136832) are registered to Copano Enterprises LLC and are located on the Copano Property (i.e., on the 11,000-acre ranch property). These wells are not used for potable purposes.

No water wells were identified within 0.5-mile radius of the affected property that supply groundwater for human consumption, agricultural purposes or any purpose which could result in exposure to human or ecological receptors.

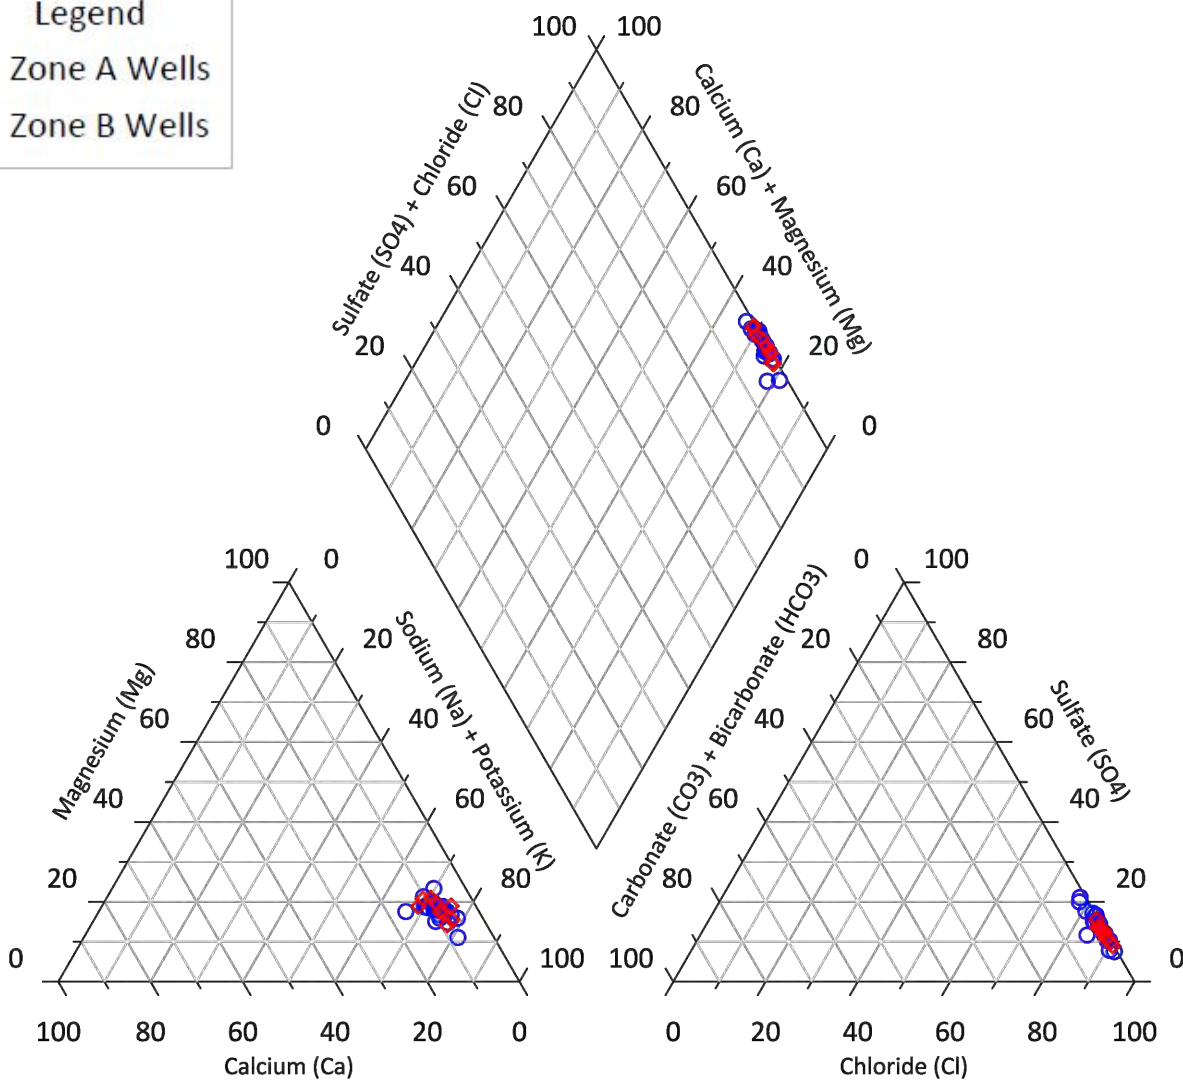
Figure 4-1: Trilinear Diagram

The cation and anion data for the monitoring well samples were plotted on a trilinear (piper) diagram (Figure 4-1). Review of this figure indicates that the geochemical signature of Site groundwater is very similar across all samples/wells given the close grouping of the data on the diagram. This indicates that there is no variability of the source of the natural salinity for all the groundwater samples collected from the wells at the Site.
