# COPANO SITE (BEDS 1-4) FINDINGS OF ENVIRONMENTAL ASSESSMENTS

## **Virtual Public Meeting**

December 15, 2020

CE Ranch LLC is hosting a virtual public meeting in cooperation with the Texas Commission on Environmental Quality (TCEQ) to discuss the Affected Property Assessment Report (APAR) prepared by Golder Associates, Inc. The report contains an evaluation of results of sample analyses of soil, groundwater, surface water and sediment at the Copano site.

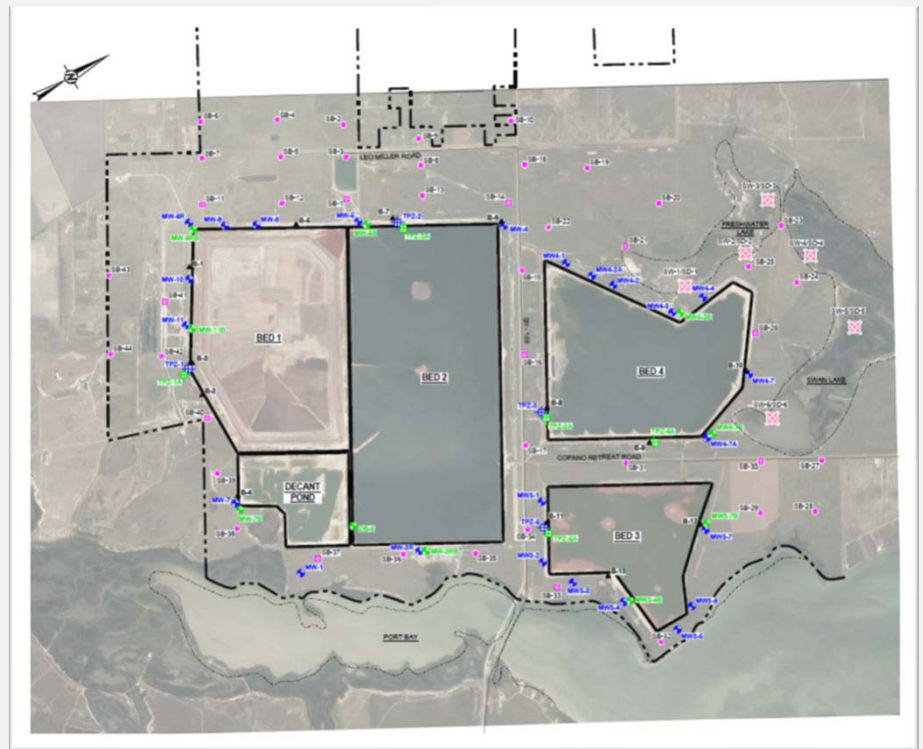
## Ecological Risk Assessment Review of Surface Soil, Surface Water and Sediment Data

- Surface soil, surface water and sediment sample results were evaluated to determine whether ecological receptors (i.e., wildlife - plants and animals) could be affected by the Site.
- Due to the low concentrations of the COCs in the sampled media, it was determined that there would be no effect to local wildlife.

**=> The sample results concluded that no further ecological assessment was warranted.**

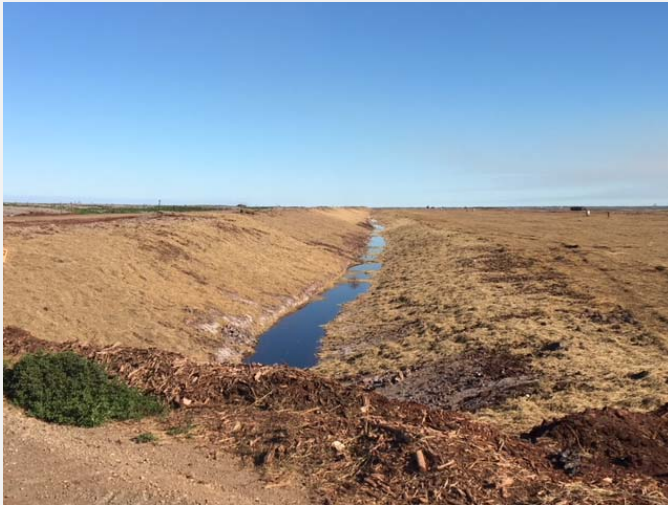
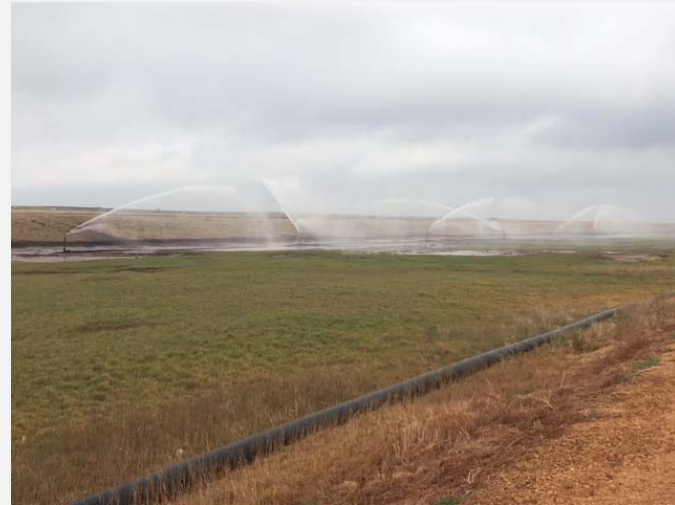
- Dusting events can occur on dry, flat surfaces during high wind conditions.
- Since 2018 dust control actions have been generally successful. These actions include promoting vegetative growth, scarifying exposed surfaces, covering with or applying water, regrading levees, and placing hay or other organic materials over exposed areas.

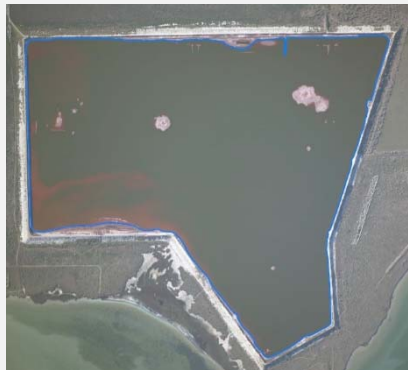
Bed 3  
1/29/2020

- Foaming events can occur as organic matter decays within impounded surface water of beds 2, 3 and 4, and then wave action caused by high wind conditions agitates the water surface and causes foam to be generated and released.
- Since 2018, foam control actions have been generally successful. These actions include lowering the water levels in Beds 3 and 4 (see photos below), installing barriers, and applying defoamer to the interior sides of the levees.
